DEPARTMENT OF TRANSPORTATION

Office of Structural Materials

Contract #: 04-0120F4Cty: SF/ALA Rte: 80 PM: 13.2/13.9File #: 69.28**WELDING INSPECTION REPORT****Resident Engineer:**Siegenthaler, Peter**Address:** 333 Burma Road**City:** Oakland, CA 94607**Report No:** WIR-018945**Date Inspected:** 30-Nov-2010**Project Name:** SAS Superstructure**OSM Arrival Time:** 700**Prime Contractor:** American Bridge/Fluor Enterprises, a JV**OSM Departure Time:** 1900**Contractor:** Zhenhua Port Machinery Company, Ltd (ZPMC), Changxing Island **Location:** Shanghai, China**CWI Name:** Xu Le Feng**CWI Present:** Yes No**Inspected CWI report:** Yes No N/A**Rod Oven in Use:** Yes No N/A**Electrode to specification:** Yes No N/A**Weld Procedures Followed:** Yes No N/A**Qualified Welders:** Yes No N/A**Verified Joint Fit-up:** Yes No N/A**Approved Drawings:** Yes No N/A**Approved WPS:** Yes No N/A**Delayed / Cancelled:** Yes No N/A**Bridge No:** 34-0006**Component:** TOWER & OBG Components**Summary of Items Observed:**

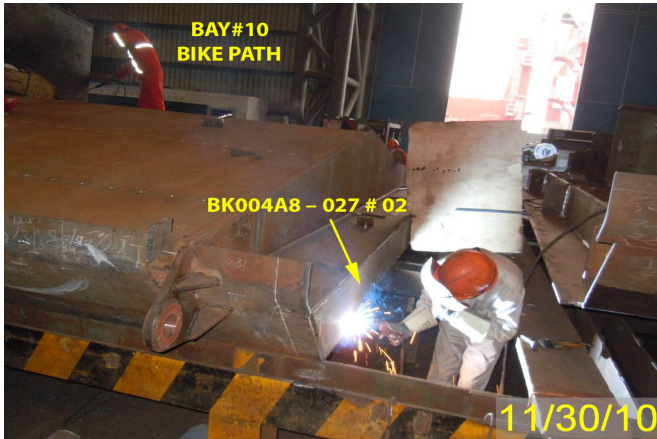
Weld joint # 02 located on Bike Path BK004A8 – 027. Welder is identified as 040302. ZPMC Quality Control (QC) Inspector is identified as Yu Zhi Lai. The welding variables recorded by QC appeared to comply with the WPS – B – T – 2332 – TC – P4 – F. (See attached photo)

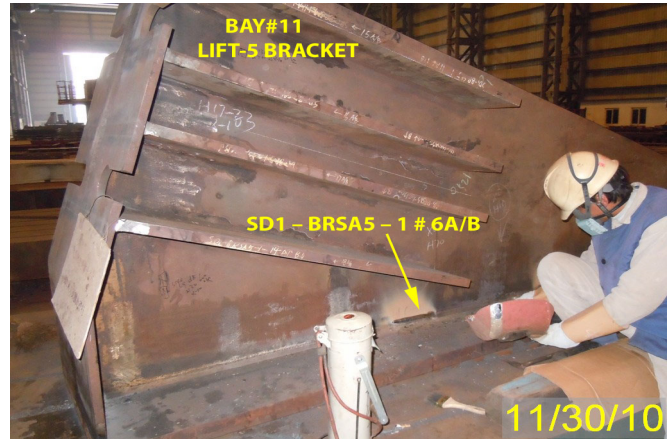
Repair welding of weld joint # 06 located on Lift-5 Bracket SD1 – BRSA5 – 1 as per the weld repair report T-WR3776. Welder is identified as 046769. ZPMC Quality Control (QC) Inspector is identified as Li Bin. The welding variables recorded by QC appeared to comply with the WPS – 485 – SMAW – 2G (2F) – Repair - 1. (See attached photo)
